# CITY OF UTICA RESERVOIR # 4

## PHASE I INSPECTION REPORT

**Name of Dam: Utica Reservoir No. 4 Dam  
County and State: Oneida County, New York  
Inventory Number: NY 00198**

**Date: July 5, 1978**

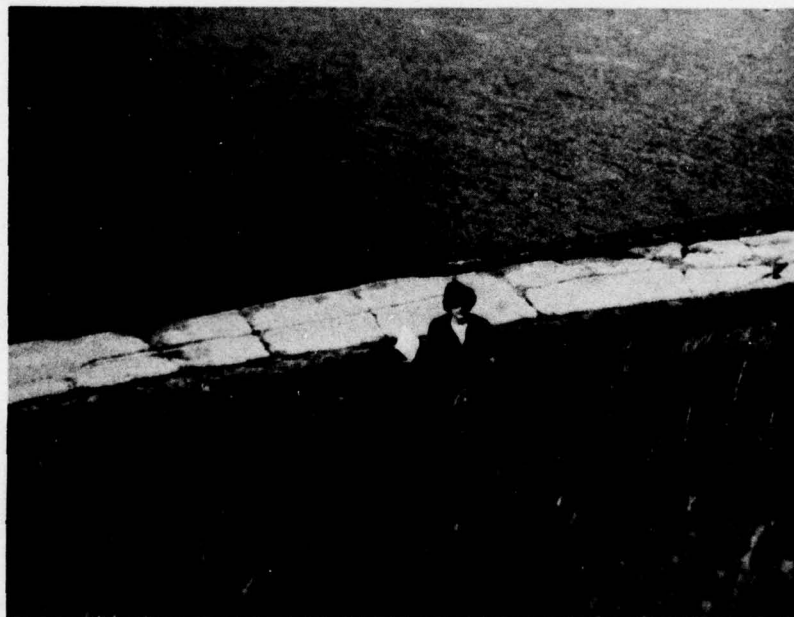
DOWNSTREAM FACE

b. Dam - During the inspection, the entire downstream slope and crest of embankment were covered with 3-foot deep grass and small bushes. Although no indication of slope misalignment was evident, observations were severely limited by the tall grass. A large number of burrow holes were encountered in a random distribution over the downstream face. It is estimated that the average distribution of these burrows is about one every 300 square feet. A four foot square area of standing water was noted at the downstream toe near the center of the embankment. The ground surface surrounding this area appeared saturated.

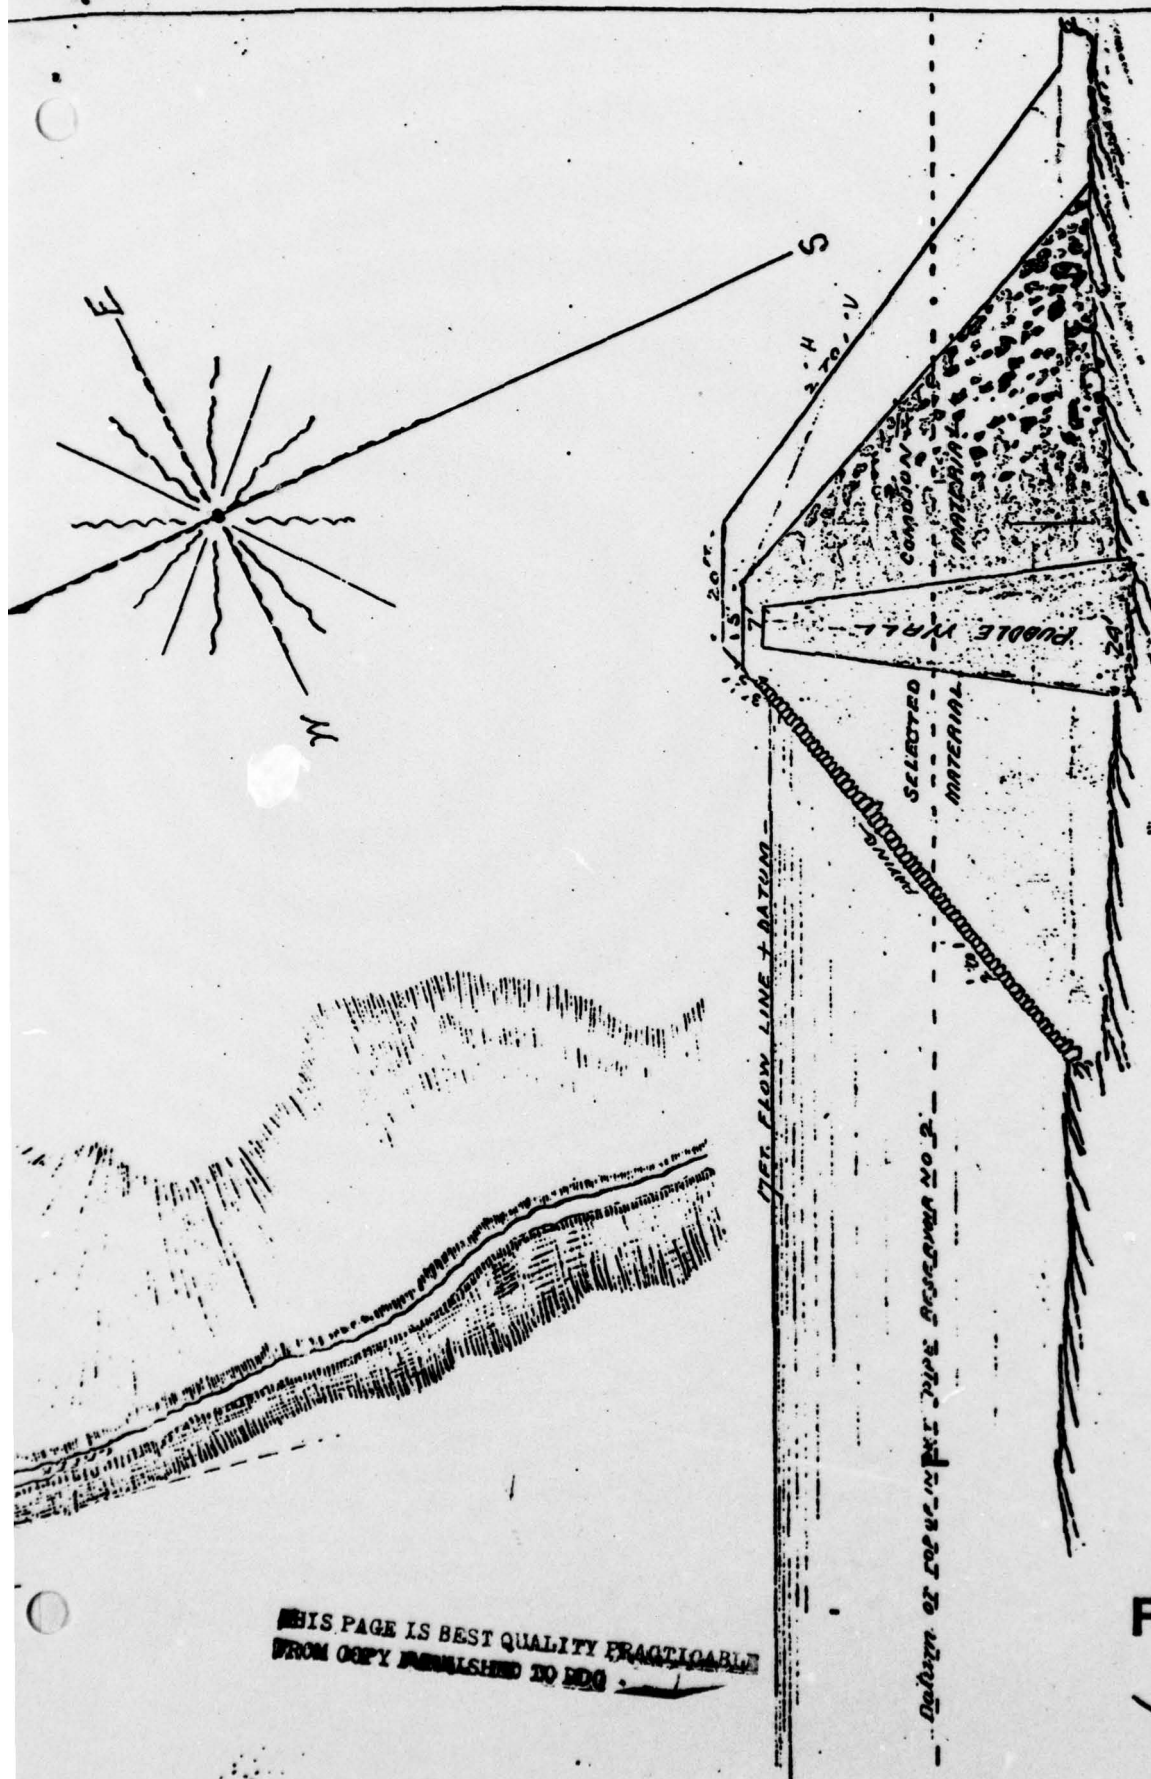
FIGURE 4

No engineering data or drawings were made available for the Utica Reservoir No. 4 dam. However, a typical section of the embankment for Reservoir No. 5 is depicted in Figure 4. The City Engineer reported that Reservoir No. 4 embankment is similarly zoned.
